## **Advances in Feature Identification using Tri-Axial MFL Sensor Technology**

**Scott Miller**  
**BJ Pipeline Inspection Services**  
**Calgary, Alberta**

### **ABSTRACT**

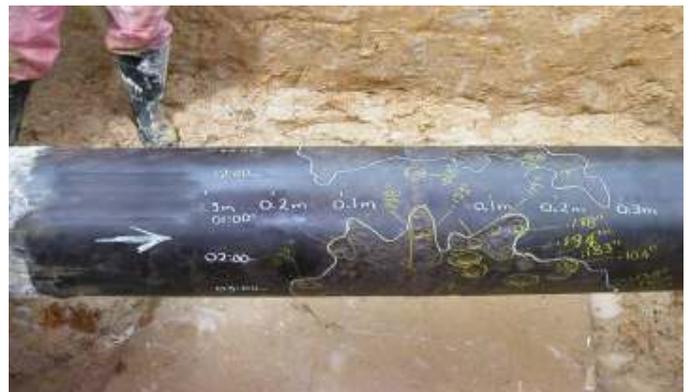
Figure 5: Photo of corresponding complex corrosion

visualize. An example is shown in Figure 4, showing a large, highly corroded area. The signals show clearly that corrosion is present, but the actual geometry of the corrosion is much less obvious. Figure 5 is a photo of the corresponding corrosion, it shows a band of a varying degree of metal loss going around the pipe.

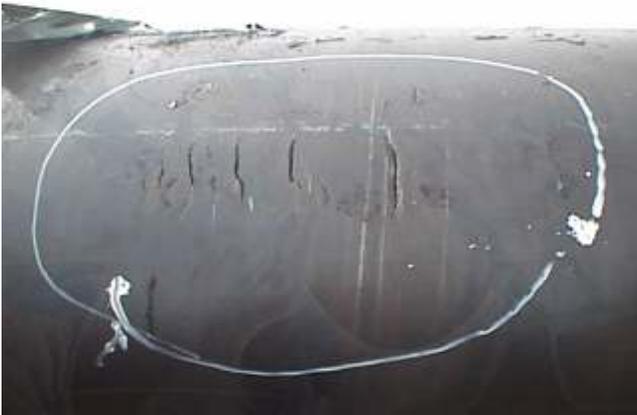
Figure 24: Photo of the corresponding defect

Usually a significant defect or damage, caused by the manufacturing process, is detected in the installation and hydro-testing of a new pipeline. Some of these features, however, go undetected until an in-line inspection. Figure 23 shows the radial data of such a feature. Utilizing the data from all three sensors it was deduced, before the excavation of the area, that the feature was not simply a metal loss due to corrosion. The subsequent excavation determined the defect to be manufacturing related, as is shown in Figure 24.

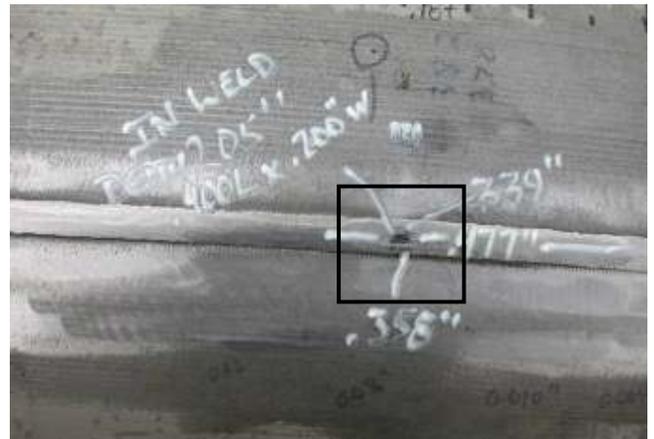
Figure 30: Photo of a seam weld flaw

During the excavation the apparent metal loss defect could not be found on the seam weld, as shown in Figure 29. The whole area was examined with an ultrasonic wall thickness probe. It was determined that there was a defect within the seam weld, or more accurately, a volumetric void. The area was lightly ground down, exposing the seam weld flaw, as shown in Figure 30.

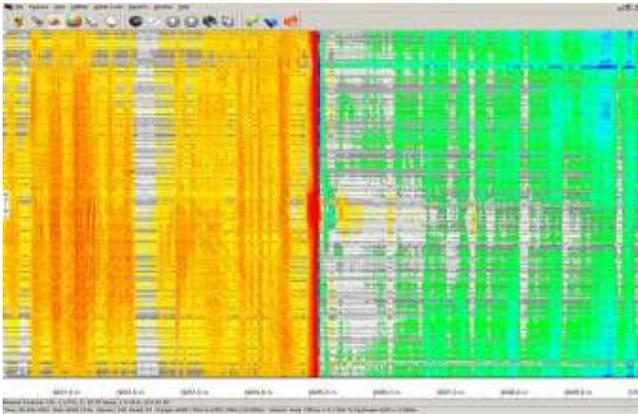
Dents were not always thought to be reliably identified by MFL data. This is mostly due to the insensitivity of axially orientated magnetic field sensors. Figure 31 depicts a screen capture of axial sensor data of a girth weld where a dent has formed. The dent is virtually undetectable in the axial data alone. The radial and circumferential oriented sensors, as shown in Figure 32, clearly show a dent on the girth weld and a smaller dent close by (circled). Dent identification demonstrates one of the major benefits of the circumferential sensor.

Figure 31: Axial only MFL data of a dent

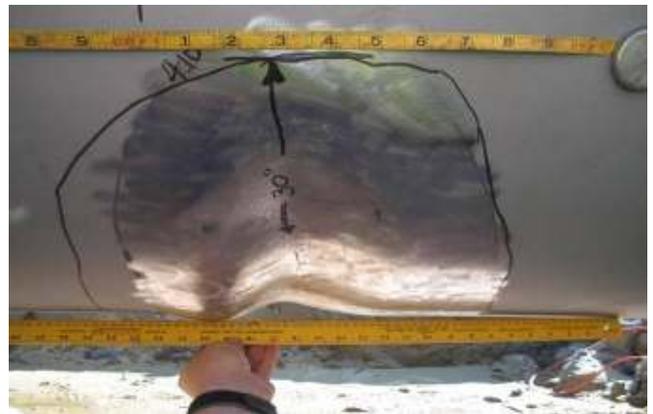
Figure 34: Photo of corresponding wrinkle

Wrinkles, which have similar plastic deformation to dents, can also be easily identified with Tri-Axial MFL inspection tools. Figure 33 shows a buckle, and since it is relatively localized, it resembles a dent. However, the signal is more vertically elongated than a dent. Figure 34 is a photo of that wrinkle.
