Polyethylene Pipeline Systems - Avoiding The Pitfalls of Fusion Welding

Dr Chris O'Connor
Senior Consultant
GL Noble Denton (Oil & Gas)
United Kingdom

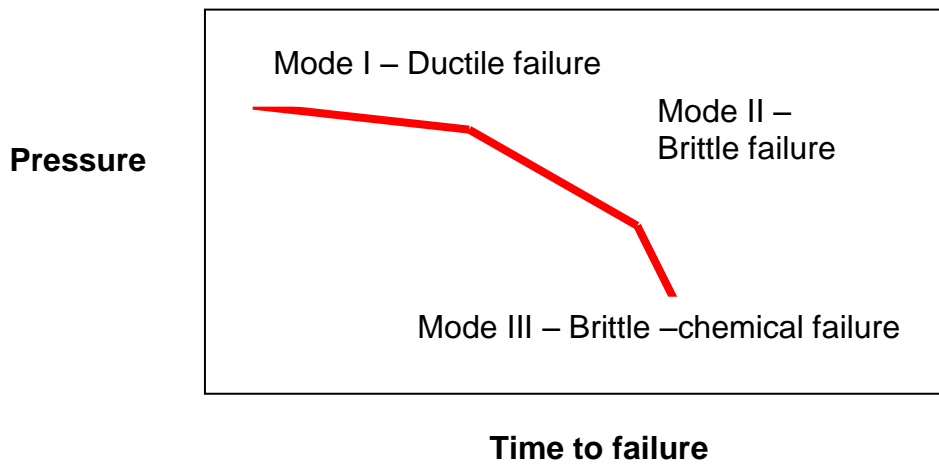
Figure 2 Failure Modes of PE Pipe - Internal Hydrostatic Pressure Testing

Early research of HDPE pipes established that SCG was one of three major failure modes for PE pipe, as shown in Figure 2⁴.

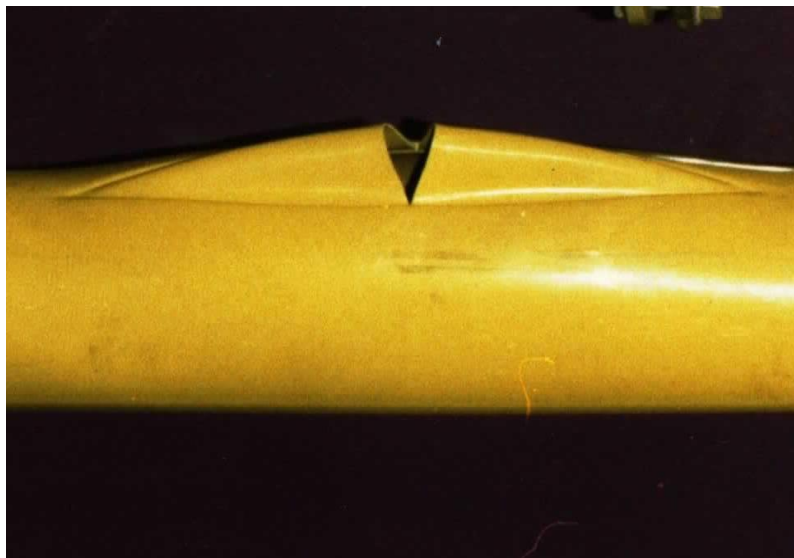
Figure 3 Ductile Failure of PE Pipe Under Internal Hydrostatic Pressure

Ductile failure mode I, results in yielding and reflects a material's propensity to undergo large-scale, irreversible 'plastic' deformation when under stress. The mechanism results in localized expansion of the wall section and final rupture of the deformed zone as shown in Figure 3.

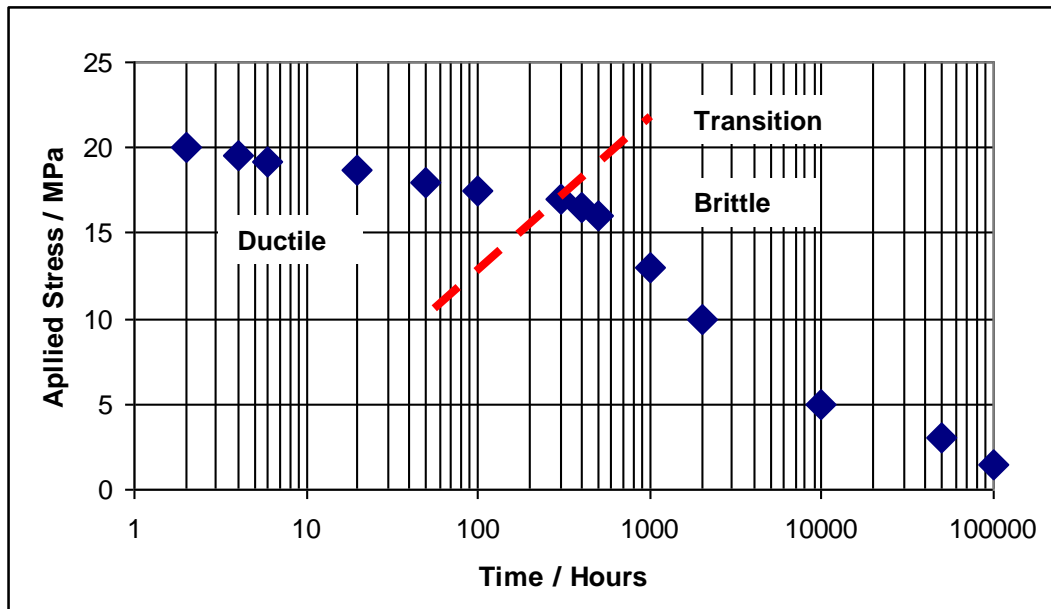
Figure 4 Creep Rupture Curve

Figure 4 is representative of a creep rupture curve where the ductile-brittle transition signals the onset SCG.

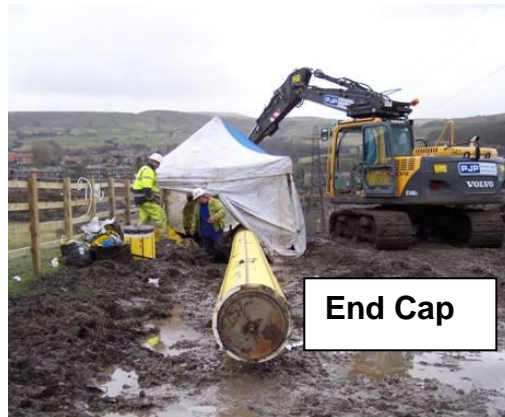
Figure 8 Protective Tents and Ground Sheets

For all fusion jointing techniques adequate preventative measures should be taken to protect the joint from contamination and the external environments prior to fusion. These measures should include the mandatory use of ground sheets and tents as shown in Figure 8. Furthermore end caps must be fitted to pipes in order to prevent ingress of water and reduce wind chill effects, which can cause a fluctuation in fusion temperature.

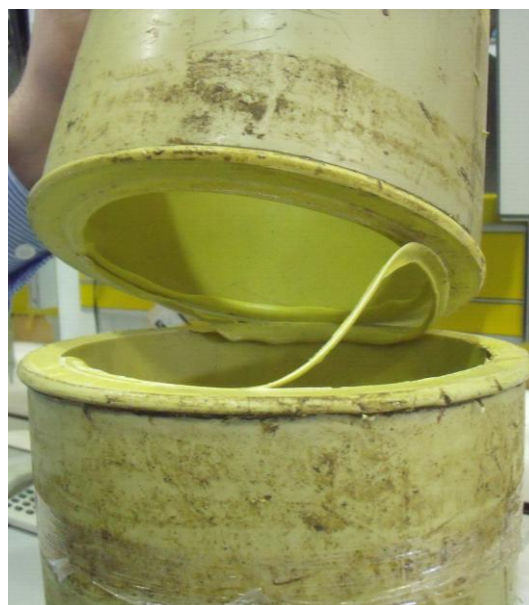
Figure 9 Catastrophic Failure of Butt Fusion Joint

A common failure mode of butt fusion joints is the initiation of SCG at stress concentration defects at the fusion weld. Secondary bending stresses, typically misalignment, uneven support or pivot points drive crack propagation circumferentially round the joint until it becomes unstable, resulting in a transition to fast crack growth and catastrophic failure as shown in Figures 9 and 10. The rate of propagation is dependent on the applied stress and can vary from weeks to years leading to fracture of the complete joint. The amount of gas released in each case is dependant on the internal pressure and diameter of the pipe in question, and can be significant.

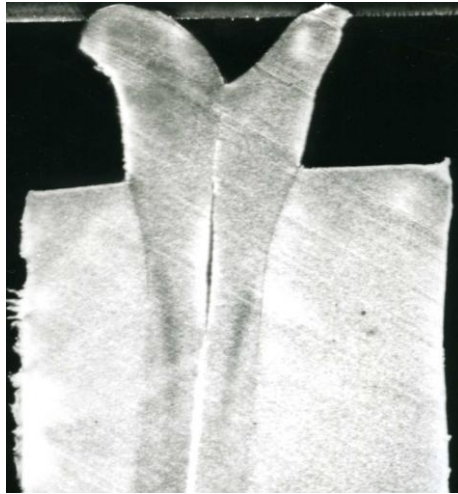
Figure 12 Cold Lap Joint

This is the time for which the pipe ends are in contact with the butt fusion heater plate. If the heat soak time is too short, the molten surfaces will not reach the required temperature and when the pipes are removed from the heater plate, the surfaces will cool quickly. The result would be an increase in melt viscosity, crystallisation prior to fusion and ultimately a 'cold' lap joint. A 'cold' lap joint (see Figure 12) may not exhibit any contamination, may be well aligned and perfectly trimmed. However, there will be no strength in the joint and if subjected to bending will separate completely.

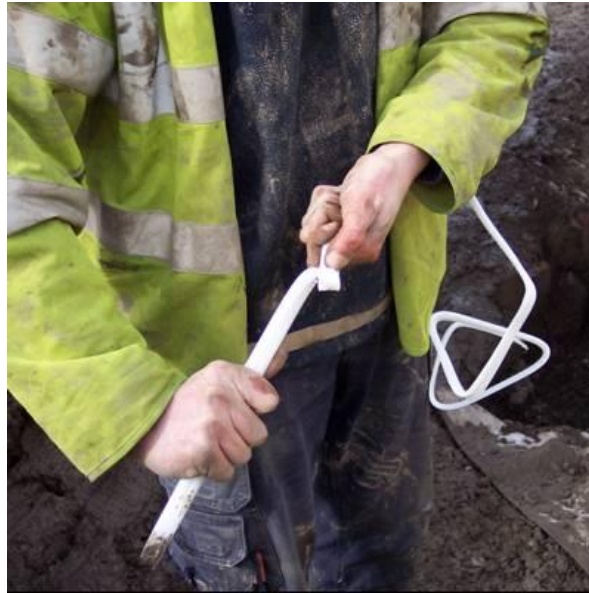
Figure 15 Bead Quality Control (Bend Back Test)

The bend back test can also be used to detect poor fusion, which will result in bead separation. Examination of the underside of the bead over its complete length also allows detection of general contamination.

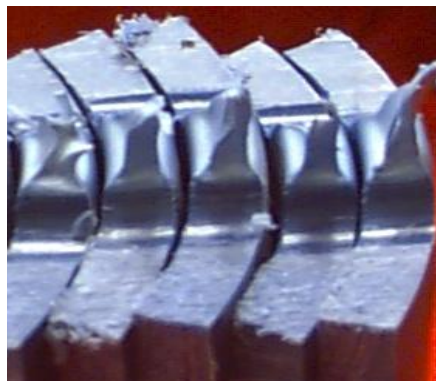
Figure 18 Ductile Failure

At the discretion of the responsible Engineer a randomly selected butt joint (or a number of joints) can be destructively tested in order to assess joint quality and give confidence in the quality of the pipeline being laid. Cut samples taken from the weld are subjected to tensile tests in accordance with BS ISO 13953⁸ (see Figure 17). Failure must be ductile, not brittle (see Figures 18 and 19) and must meet the following pass criteria;

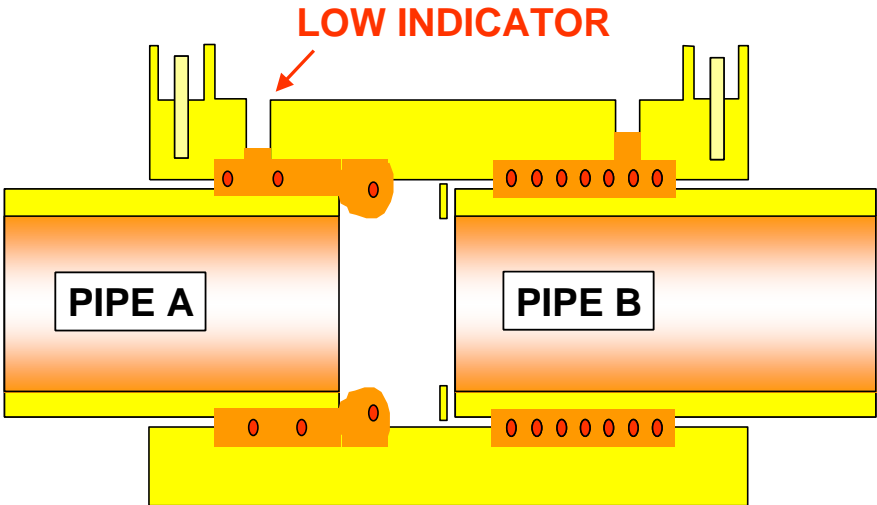
Figure 20 Incorrect Pipe End Penetration

In cases where the pipe is not pushed fully home into the socket bore (Figure 20), or where there is severe misalignment of the pipe and socket (Figure 21), the wires become exposed and molten material flows away from the joint interface (Figure 23). This in turn allows the wires to move within the molten material and can lead to the wires touching or bunching together causing short-circuiting or localised overheating. The result can be thermal degradation, void creation along the fusion interface, or a drop in energy input resulting in partial fusion. In order to negate these possible failure modes the pipe must be aligned and restrained during the fusion cycle.

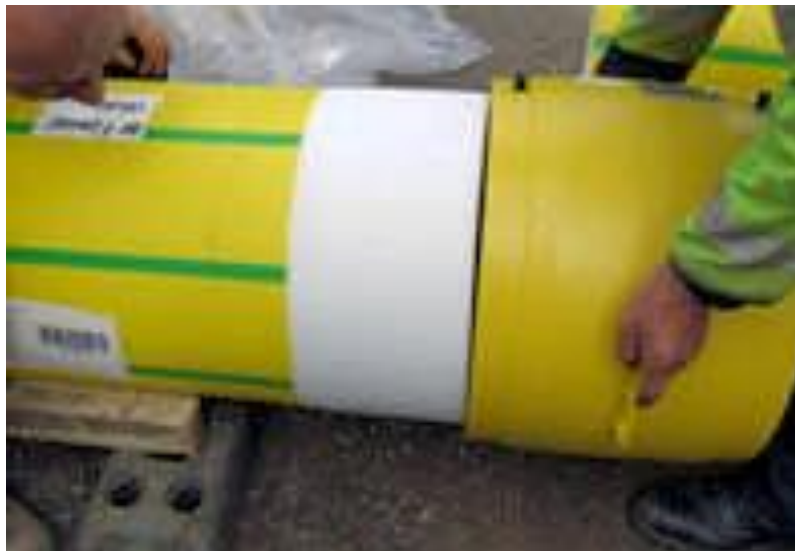
Figure 24 Peelable PE Pipe

- Reduced pipe surface damage during transportation, handling and installation.
- The ability to quickly identify, and then assess, pipe surface damage.
- Improved efficiency of pipeline installation, particularly with respect to EF joining, where the installation time is typically halved.

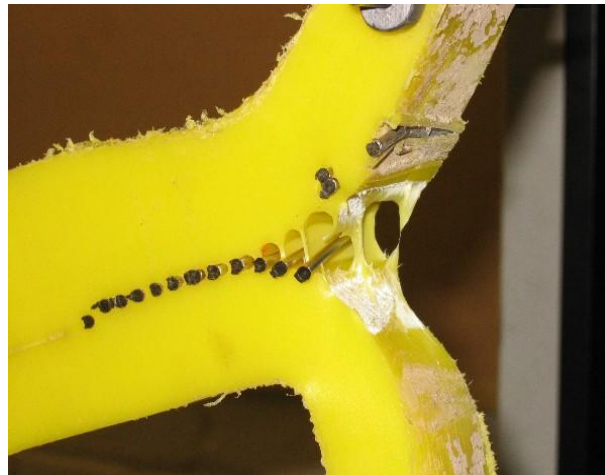
Figure 25 Tensile Testing of Electrofusion Weld Specimen

In the absence of NDT techniques, engineers can only resort to in process control destructive testing of joints in order to assess joint quality and give confidence in the quality of the pipeline being laid. Cut samples taken from the weld are subjected to tensile tests in accordance with BS ISO 13954⁹ (see Figure 25). The pass criteria is ductile interface tearing along the fusion length over a minimum length of 66 % of the apparent fusion length
